ATTACHMENT 2: INSPECTION PHOTOGRAPHS

ATTACHMENT 3: CONFIDENTIALITY NOTICE

ATTACHMENT 4: FIELD SAMPLING RESULTS

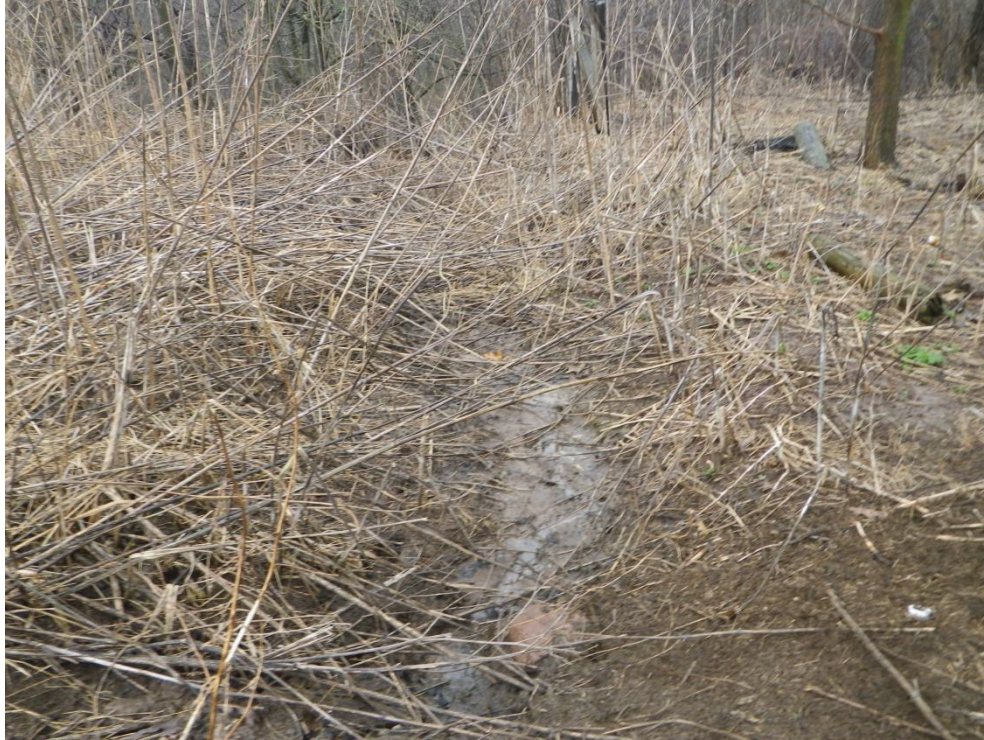
30: IMGP0283.JPG

Description: The flow in the pathway continued west and dropped down the ledge into the unnamed stream bordering the west end of the facility.

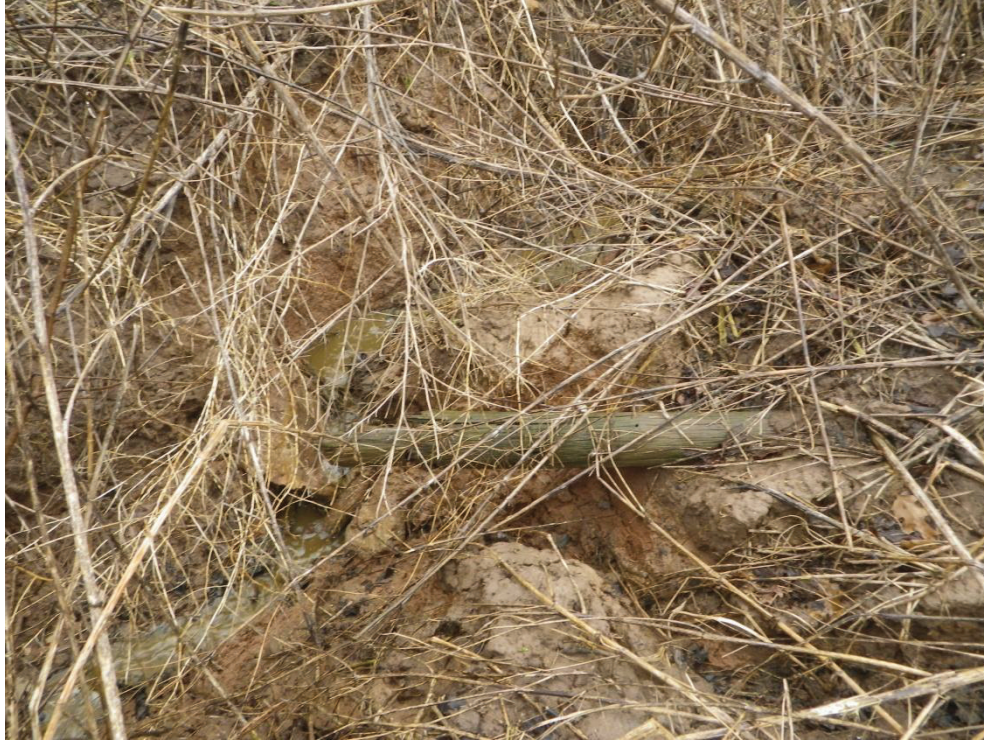
31: IMGP0284.JPG

Description: The flow in the pathway continued west and dropped down the ledge into the unnamed stream bordering the west end of the facility.

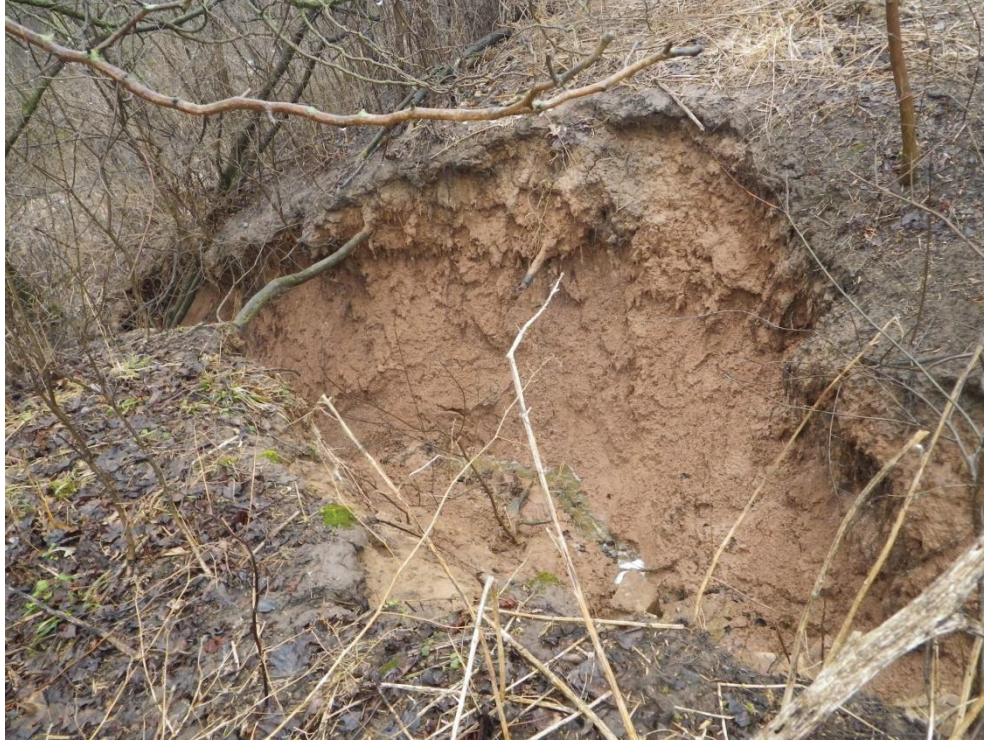
32: IMGP0285.JPG

Description: A large eroded area was observed where the flow pathway drops down the ledge and continues to the unnamed stream.

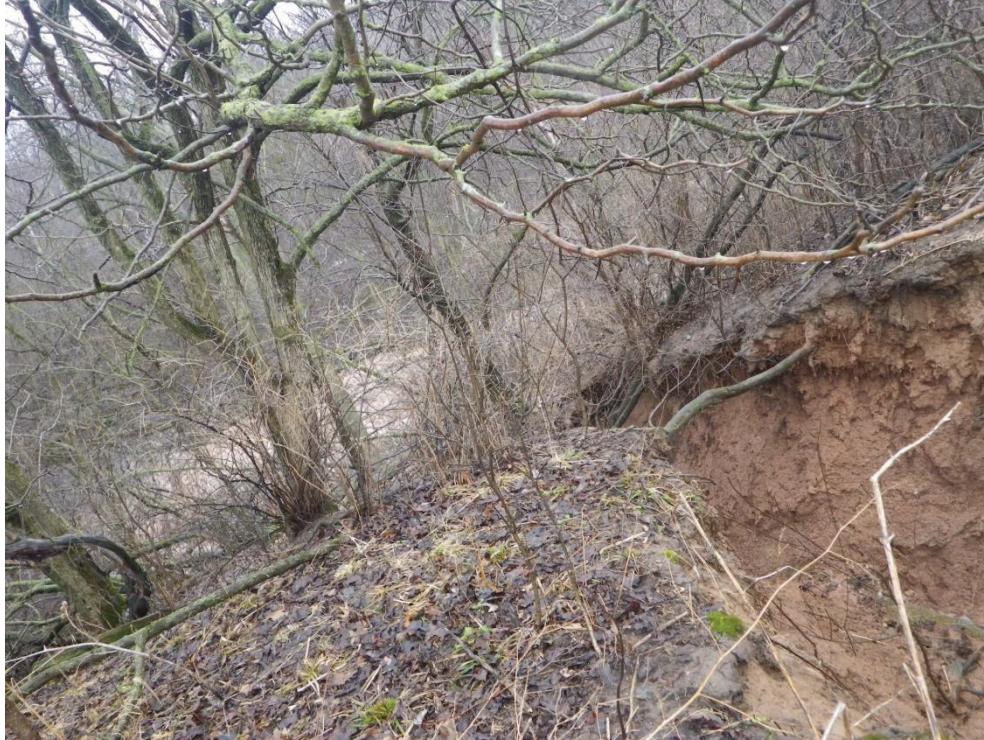
33: IMGP0286.JPG

Description: A large eroded area was observed where the flow pathway drops down the ledge and continues to the unnamed stream. The stream can be observed down the ledge.

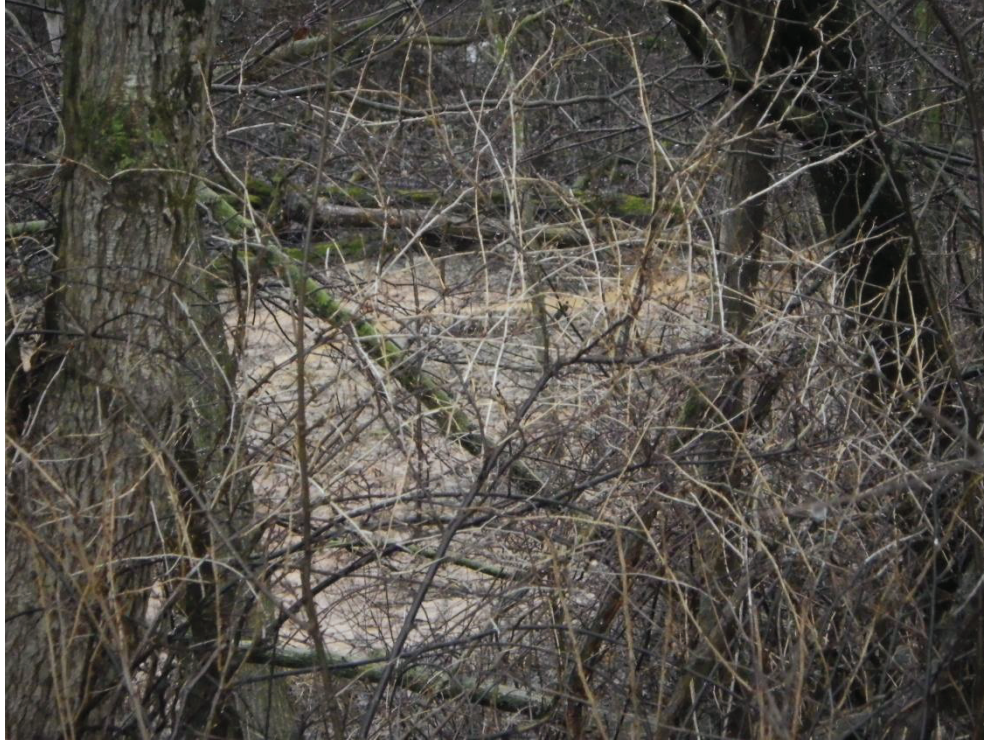
34: IMGP0287.JPG

Description: The unnamed tributary.

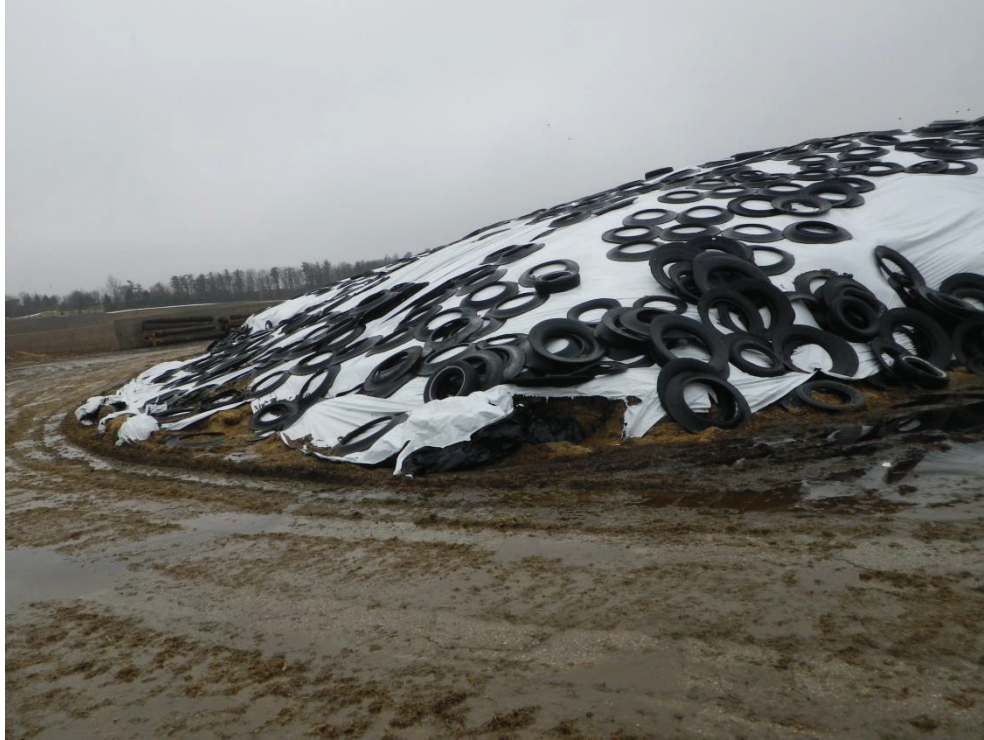
35: IMGP0288.JPG

Description: Process wastewater and feed solids were observed around the feed bunkers. The process wastewater was ponded and flowed east into a grassed area.

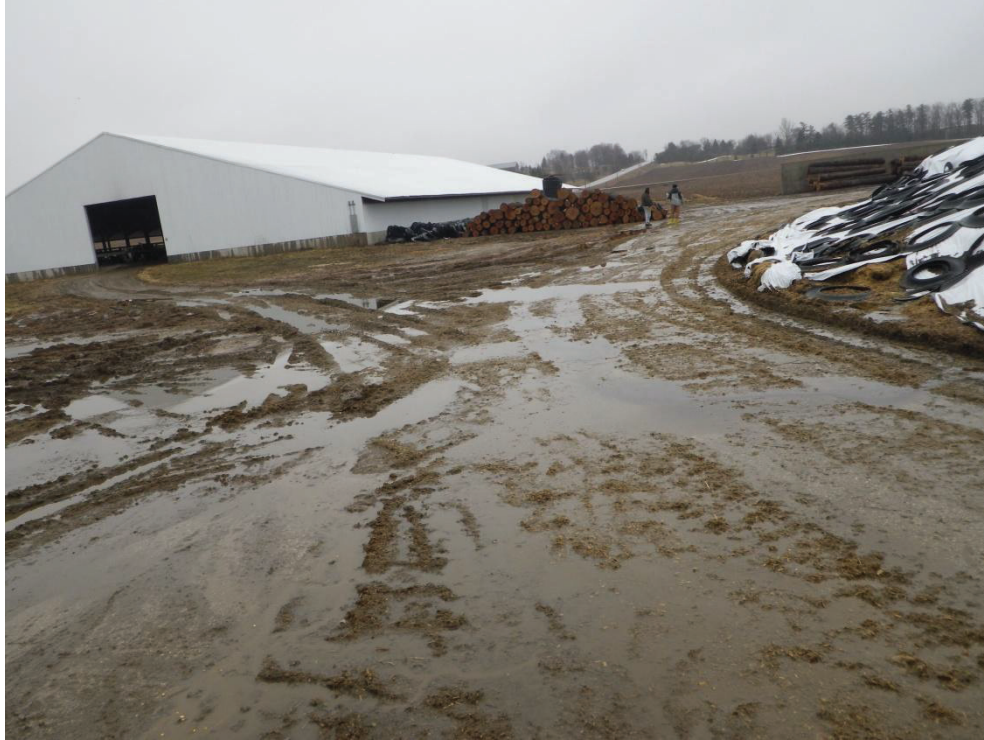
36: IMGP0289.JPG

Description: Process wastewater and feed solids were observed around the feed bunkers. The process wastewater was ponded and flowed east into a grassed area.

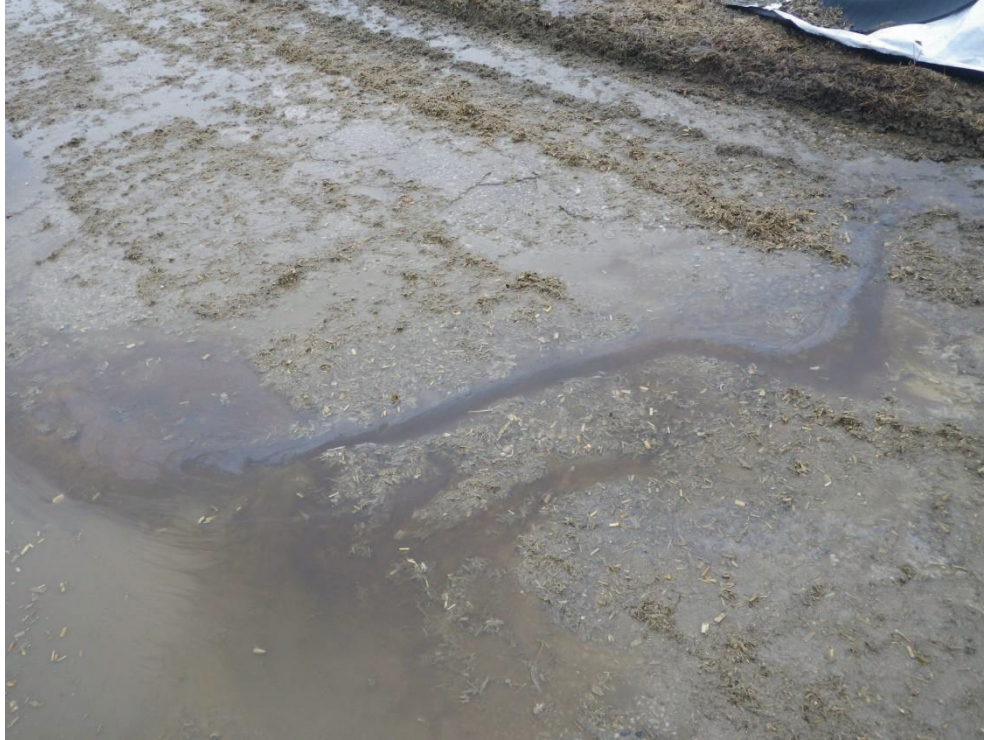
37: IMGP0290.JPG

Description: Process wastewater and feed solids flowing out the east end of the feed bunkers.

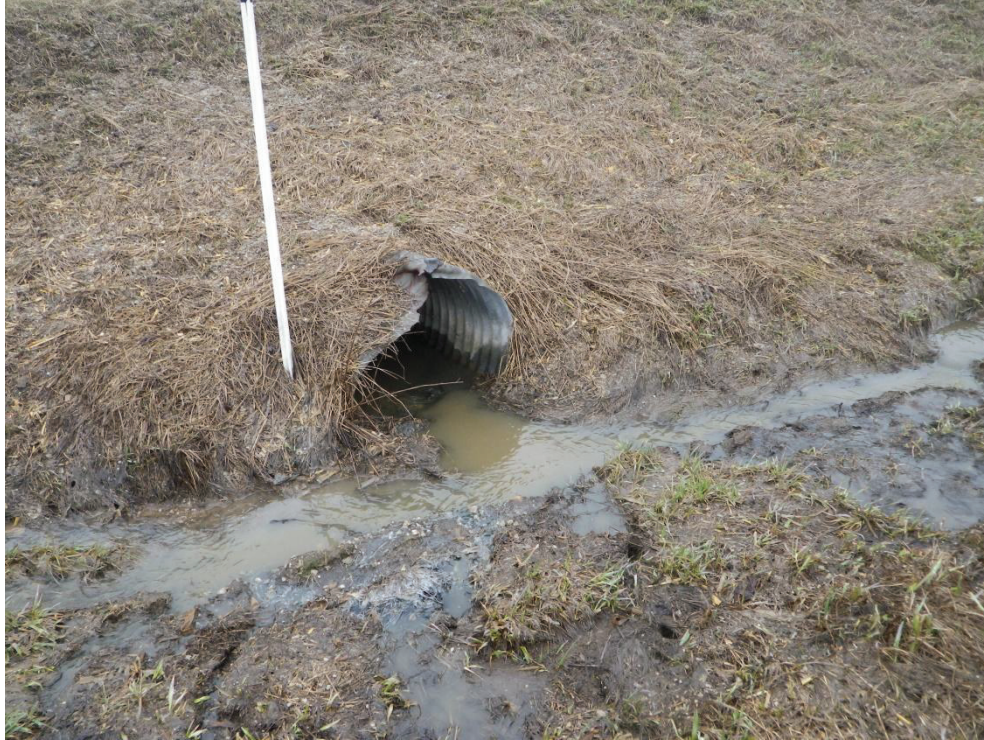
38: IMGP0291.JPG

Description: The process wastewater continued through the grassed area and outlet into the ditch. The culvert collected the flow which continued east under [REDACTED] and east along the [REDACTED] then north and continued northeast before connecting with an unnamed tributary.

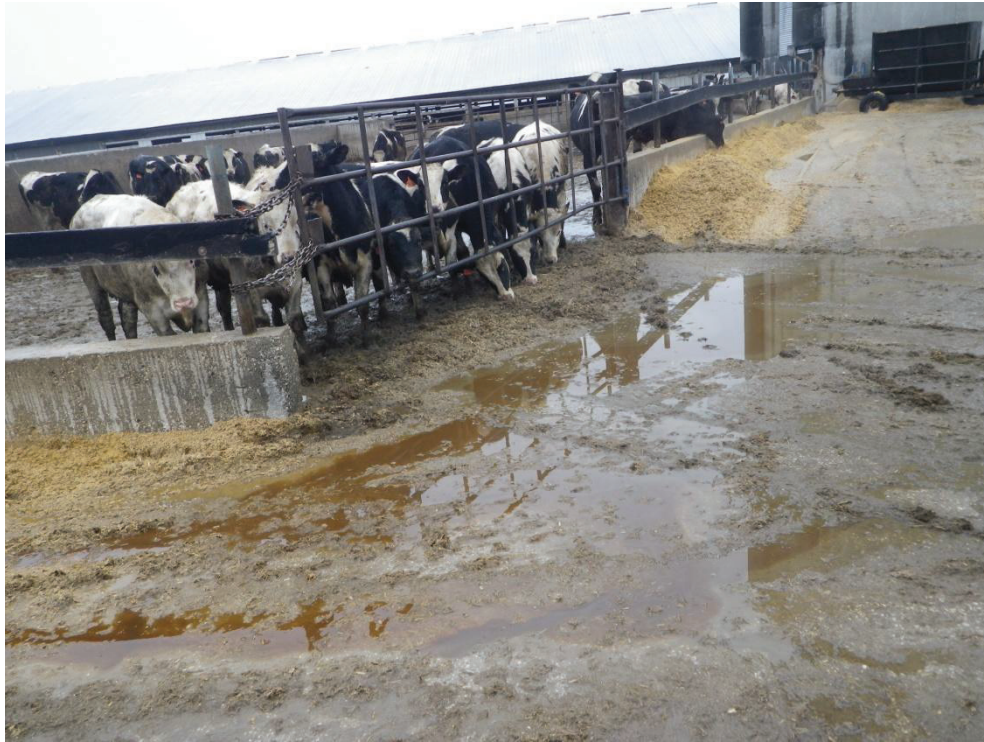
40: IMGP0293.JPG

Description: Portions of the open feedlot drained to the east through the grassed area and to the ditch.

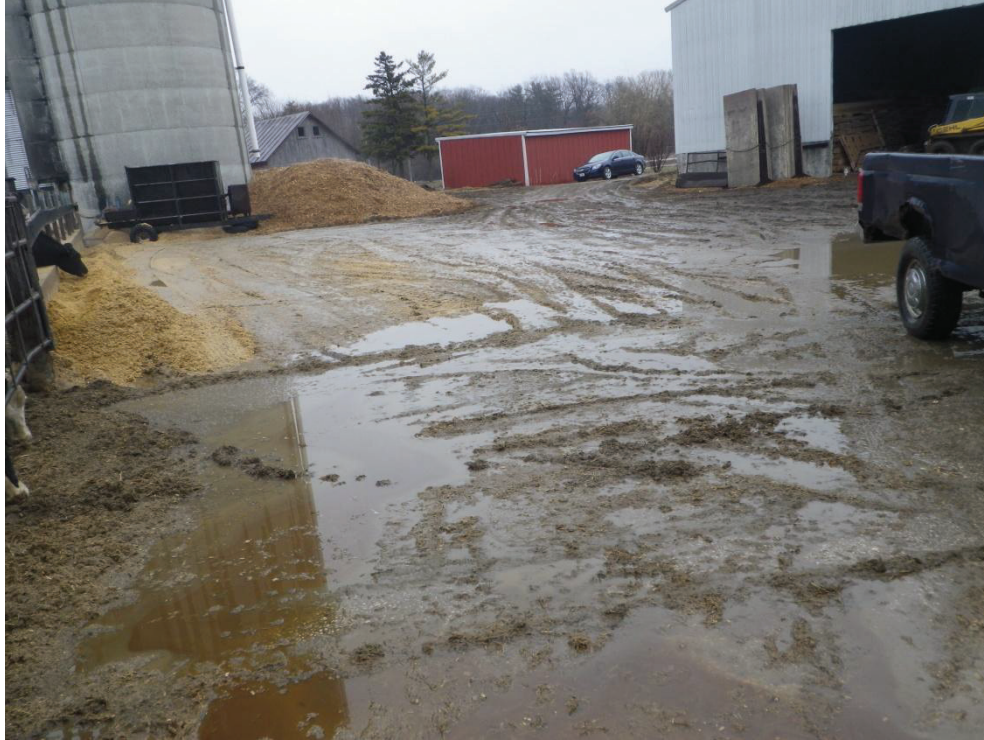
41: IMGP0294.JPG

Description: Feed, manure and process wastewater flowed southeast to the grassed area near the southeast corner of the open feedlot.

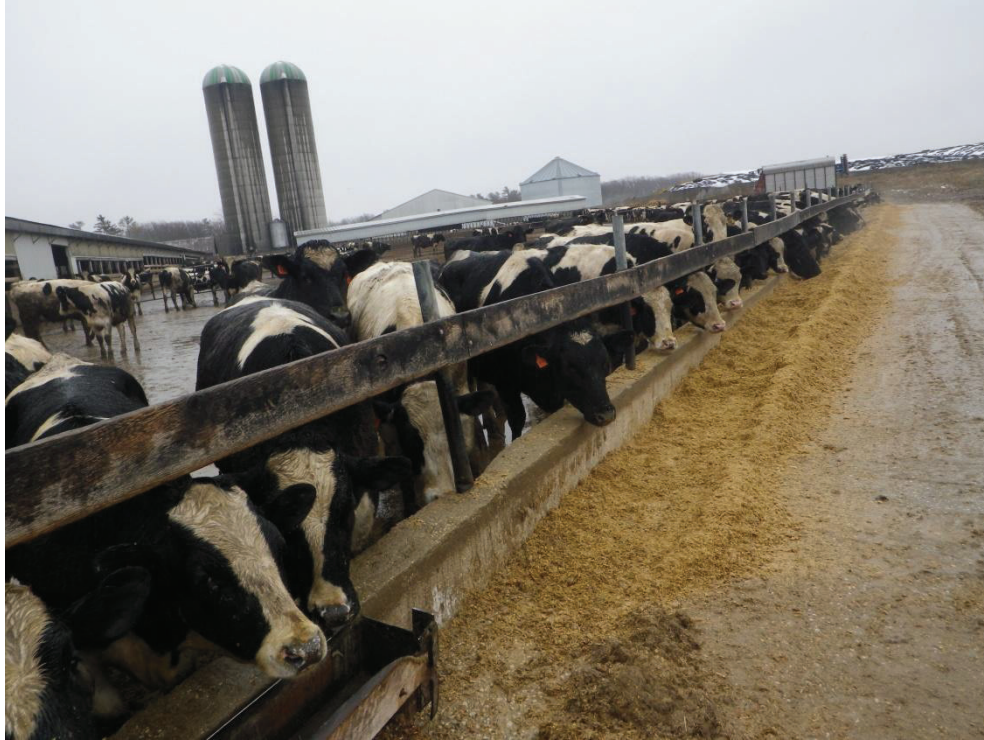
42: IMGP0295.JPG

Description: Feed and process wastewater had no containment along the south end of the open feedlot.

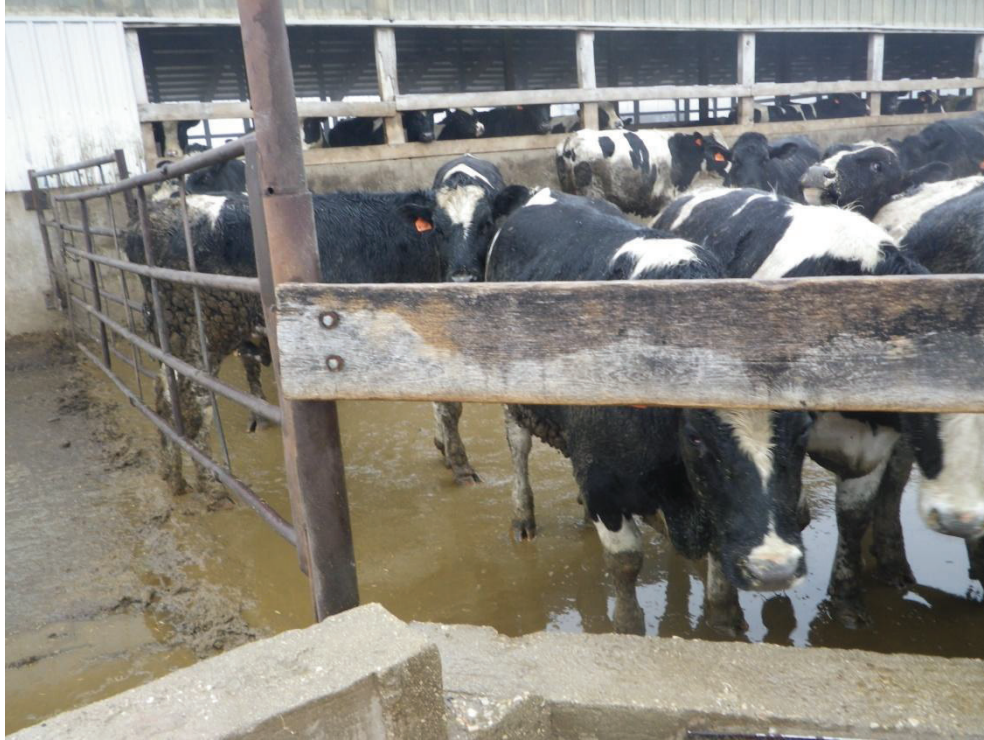
43: IMGP0296.JPG

Description: Portions of the open feedlot flowed to the west.

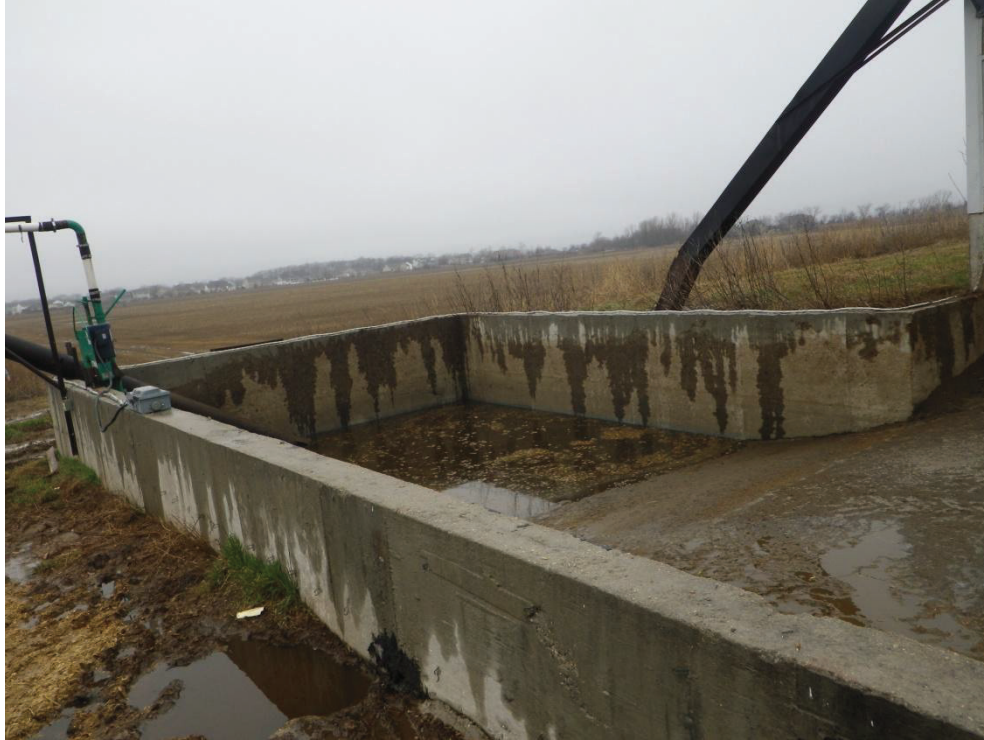
45: IMG0298.JPG

Description: Portions of the open feedlot flowed to the west. The manure and process wastewater is contained in a concrete pit which is pumped out when needed and transferd to the concrete manure pits on the Home site or land applied.

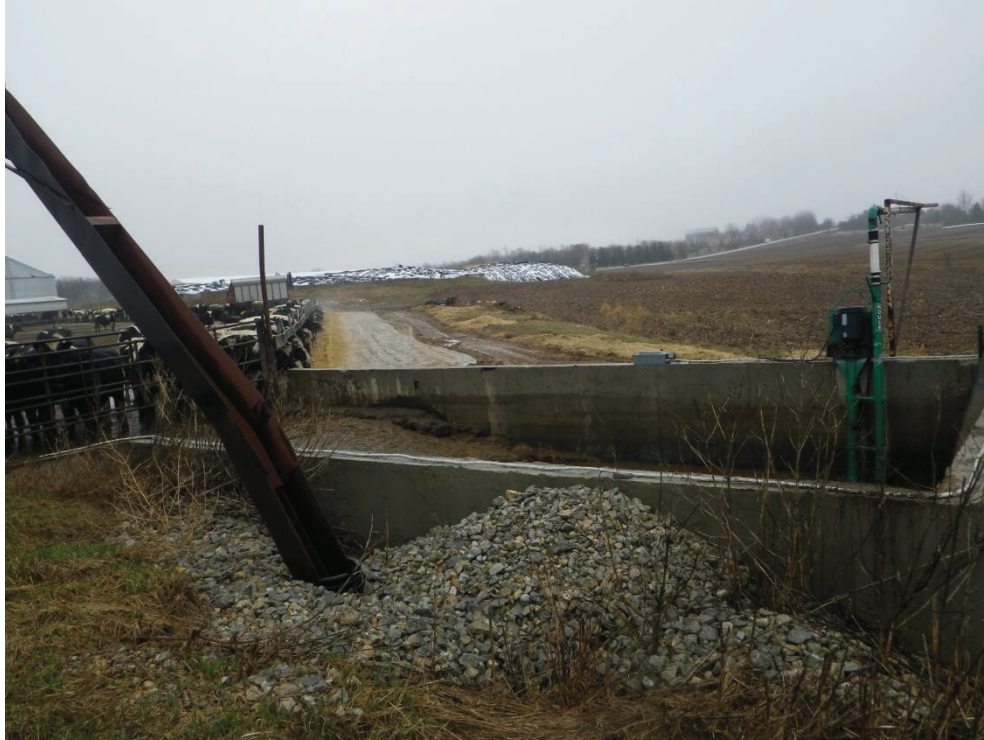
46: IMGP0299.JPG

Description: Concrete pit and feed pathway.

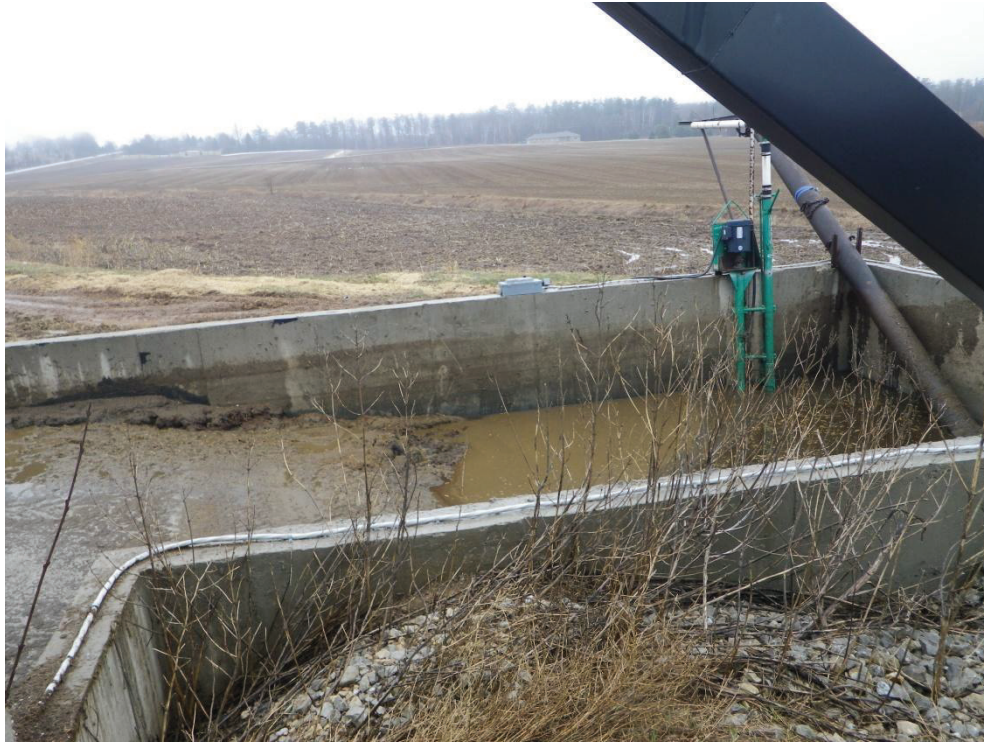
47: IMGP0300.JPG

Description: Concrete pit

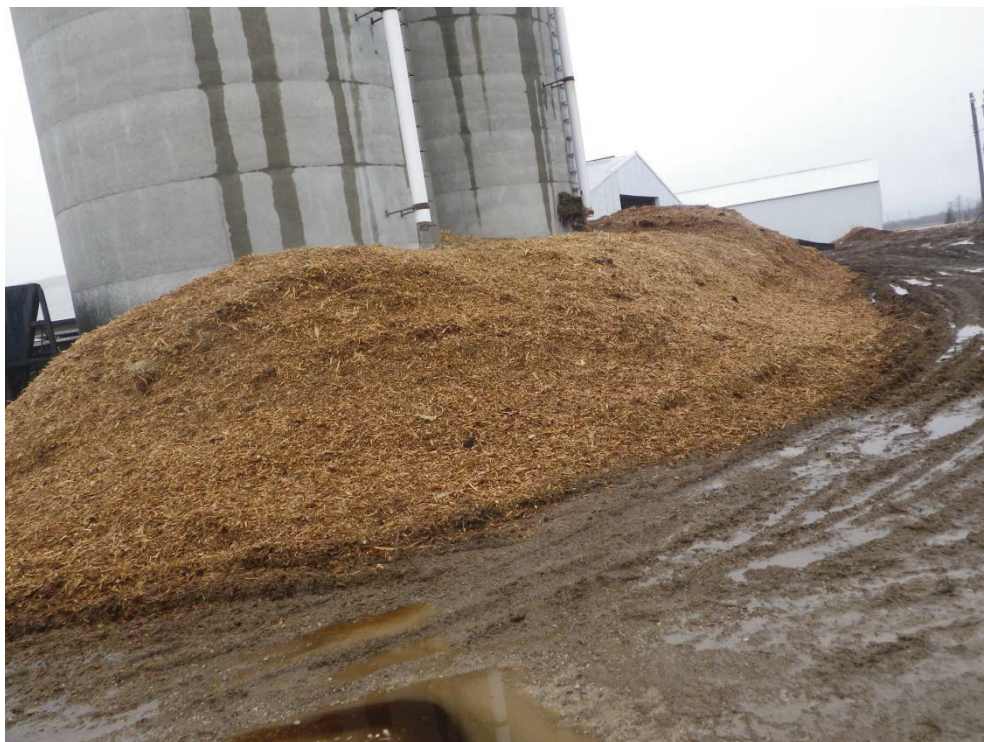
48: IMGP0301.JPG

Description: Cornstalk and woodchip bedding material east of the open feedlot.

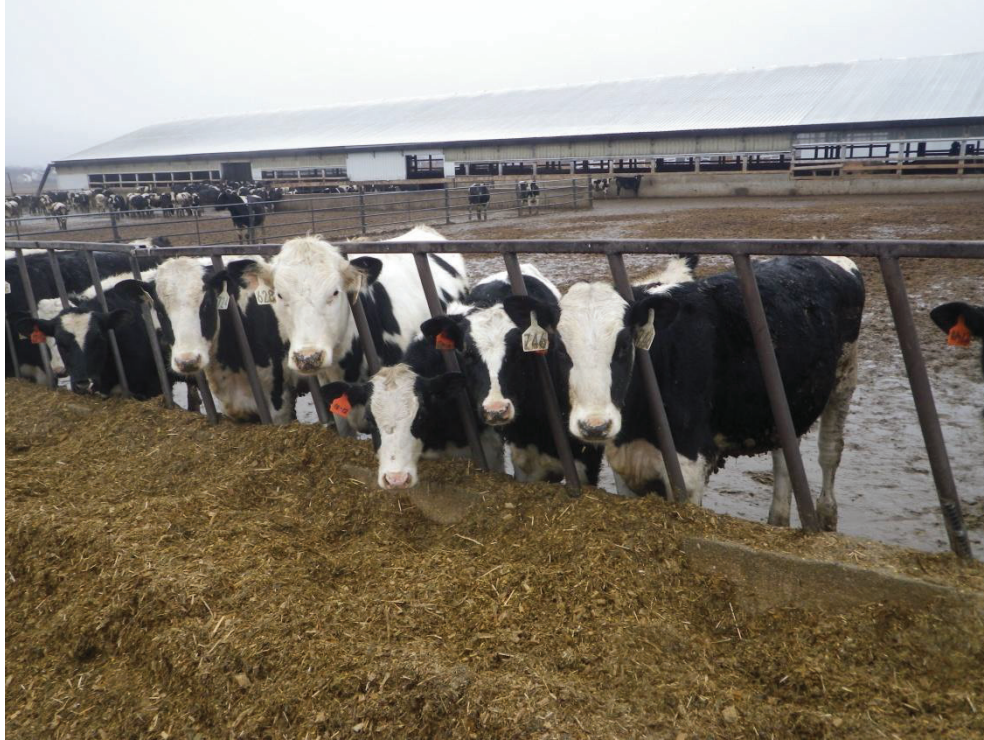
49: IMGP0302.JPG

Description: Feed in pathways adjacent to the south end of the open feedlot.

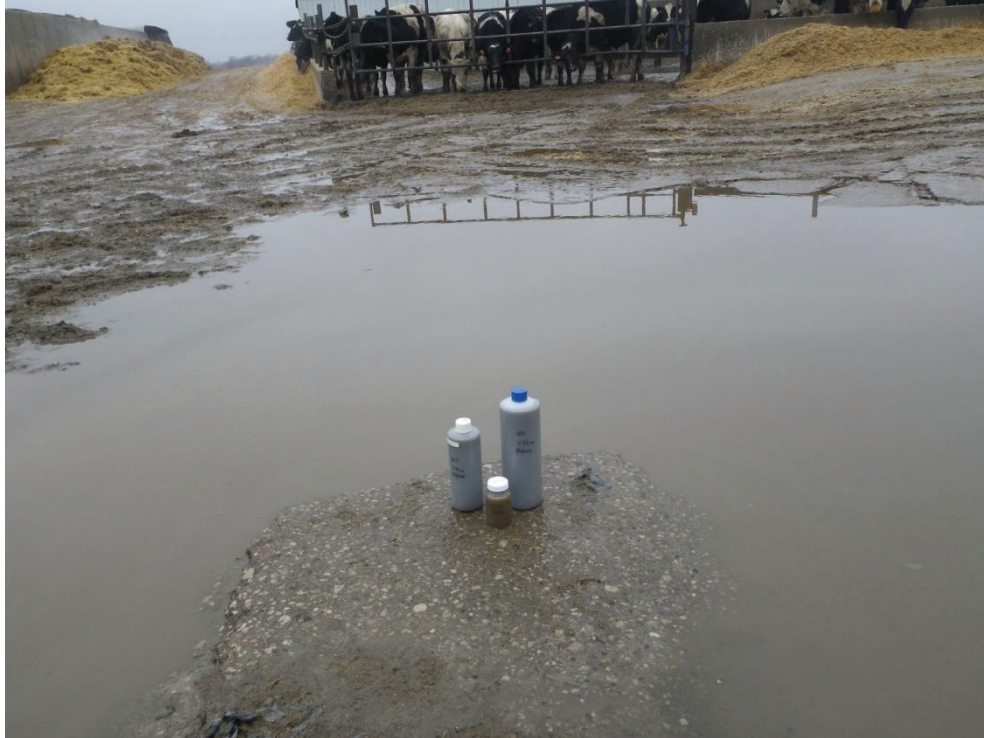
50: IMGP0303.JPG

Description: Sample S02, collected in puddle/pathway adjacent to the open feedlot.

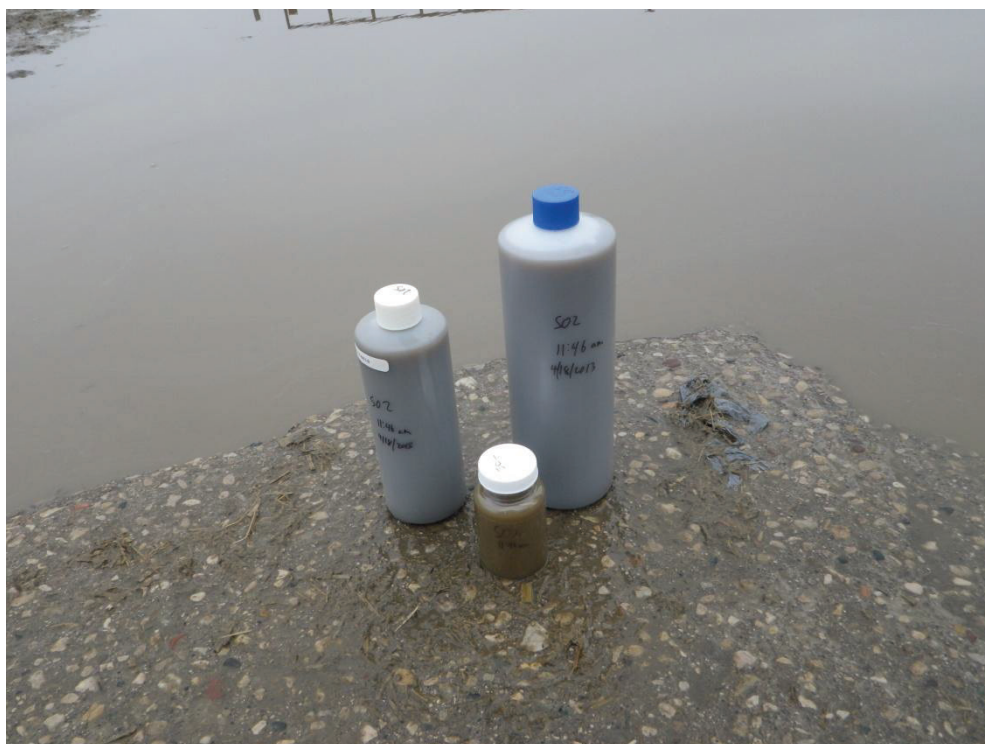
51: IMGP0304.JPG

Description: Sample S02, collected in puddle/pathway adjacent to the open feedlot.

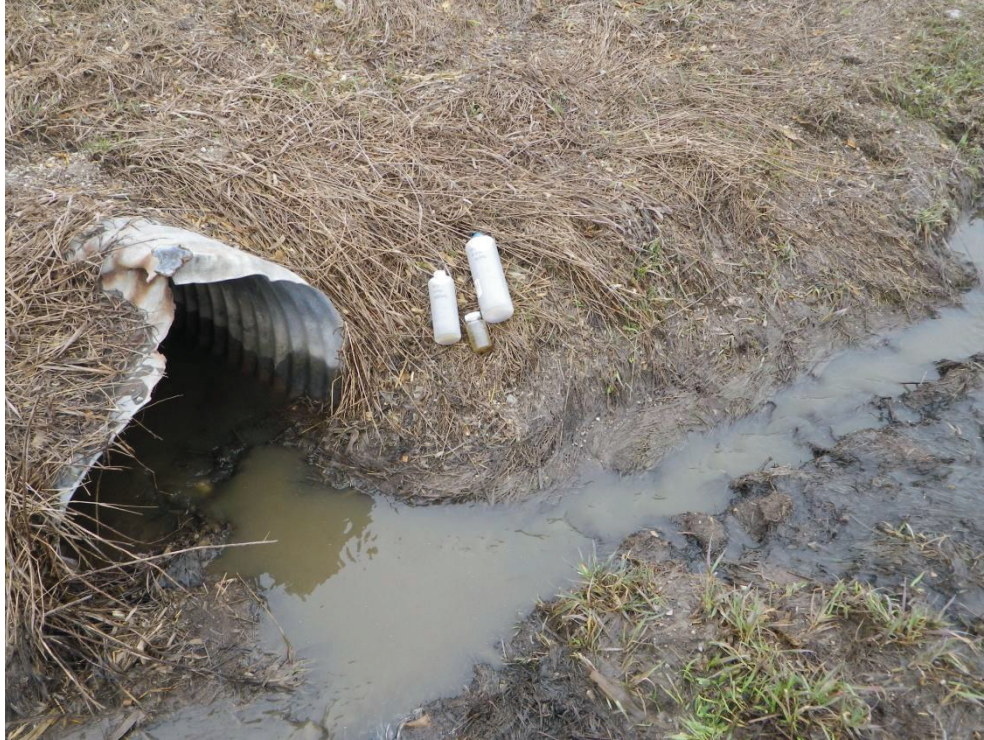
52: IMGP0305.JPG

Description: Sample S03, in ditch before flow enters the culvert under [REDACTED]

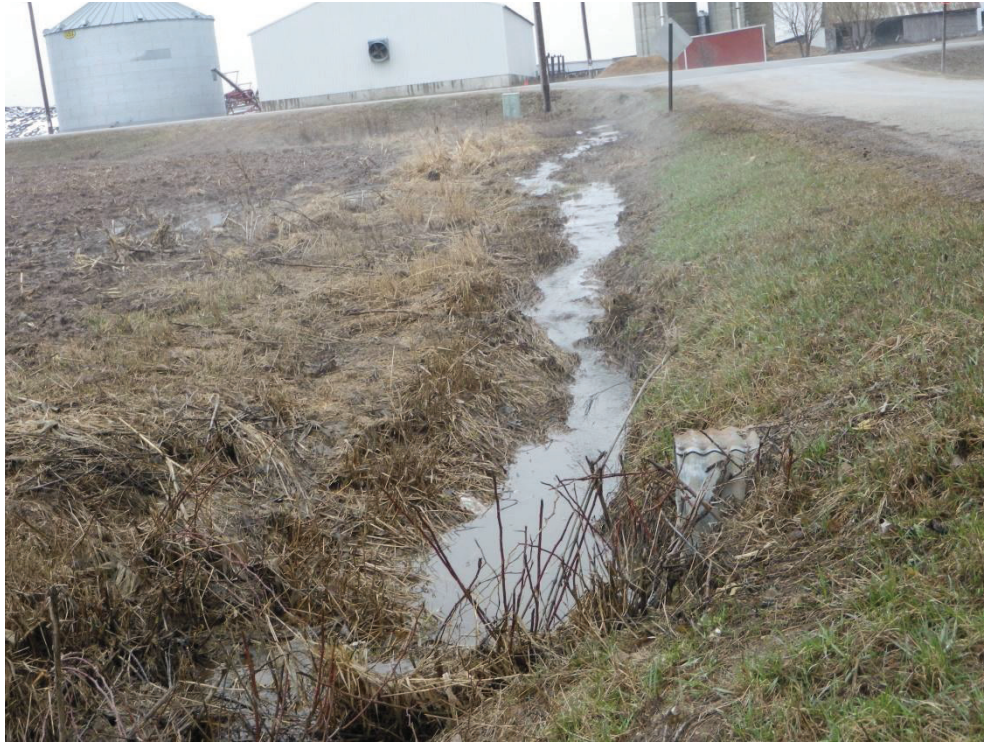
54: IMGP0307.JPG

Description: Flow from portions of the open lots and process wastewater from the feed flowed through the culvert and under the [REDACTED] to the east. The flow then turns north through another culvert under [REDACTED]

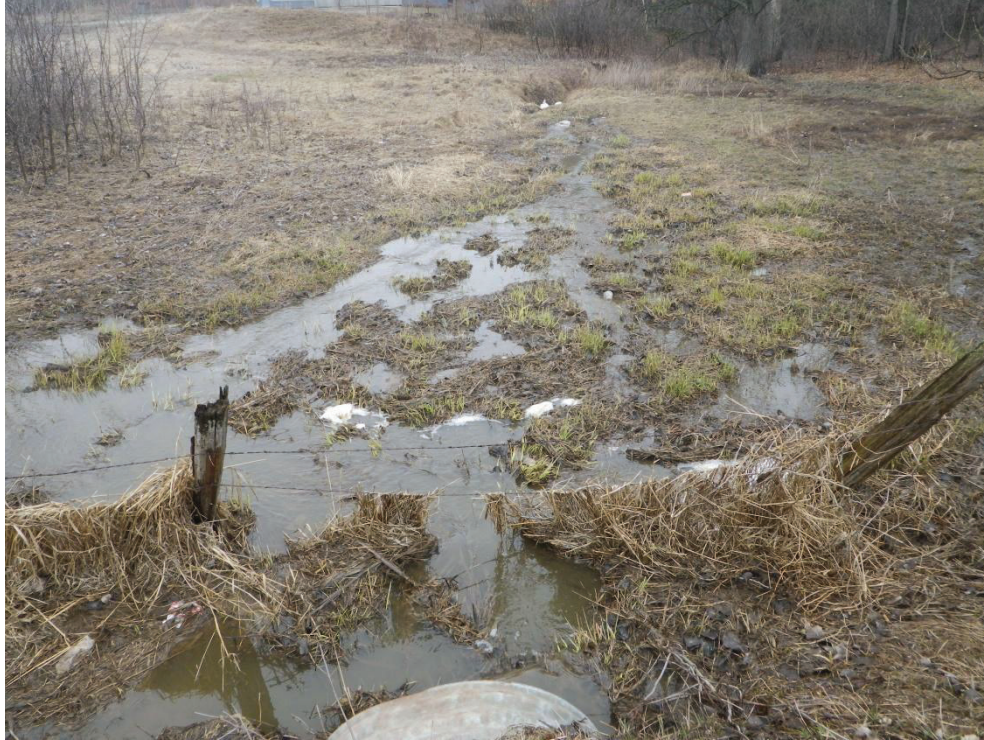
55: IMGP0308.JPG

Description: The flow continues north under [REDACTED] and through the field to the northeast and connects with an unnamed tributary.

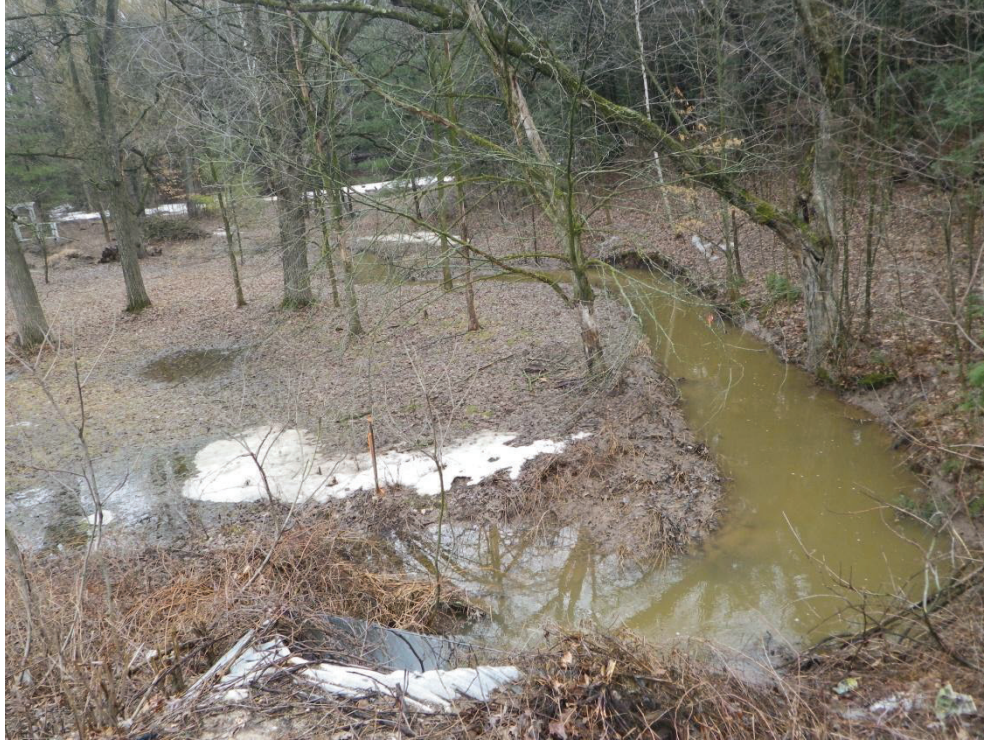
56: IMGP0309.JPG

Description: Unnamed tributary flows North to Bower Creek. The culvert was approximately 8-10 ft in diameter at the crossing under [REDACTED]

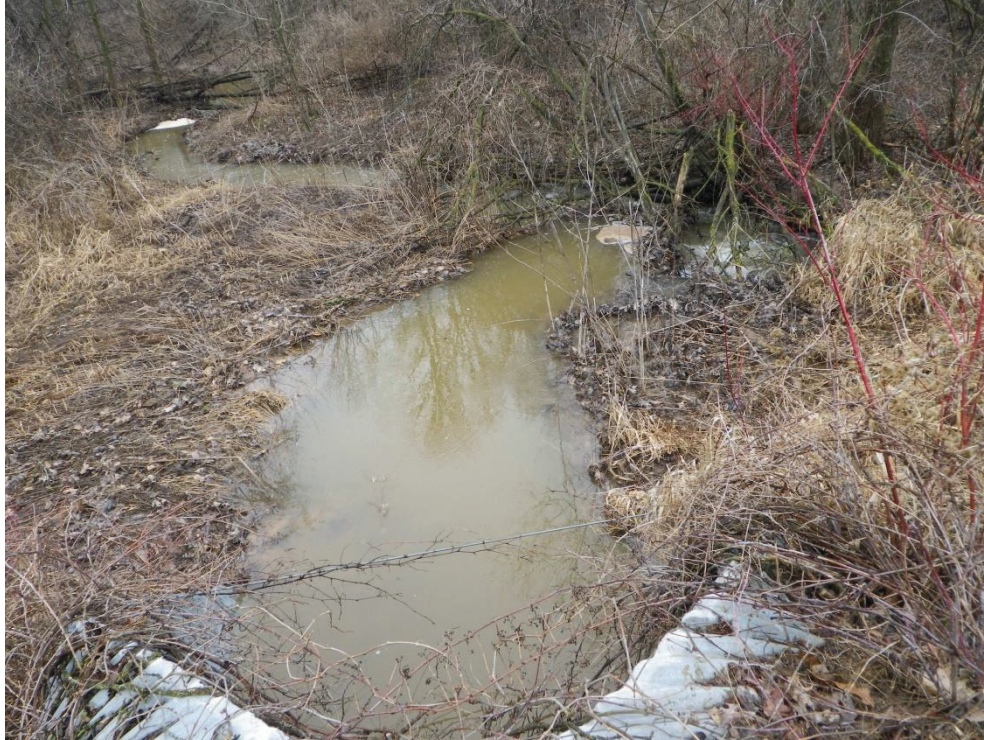
57: IMGP0310.JPG

Description: Unnamed tributary flows north to Bower Creek. The culvert was approximately 8-10 ft in diameter at the crossing under [REDACTED]

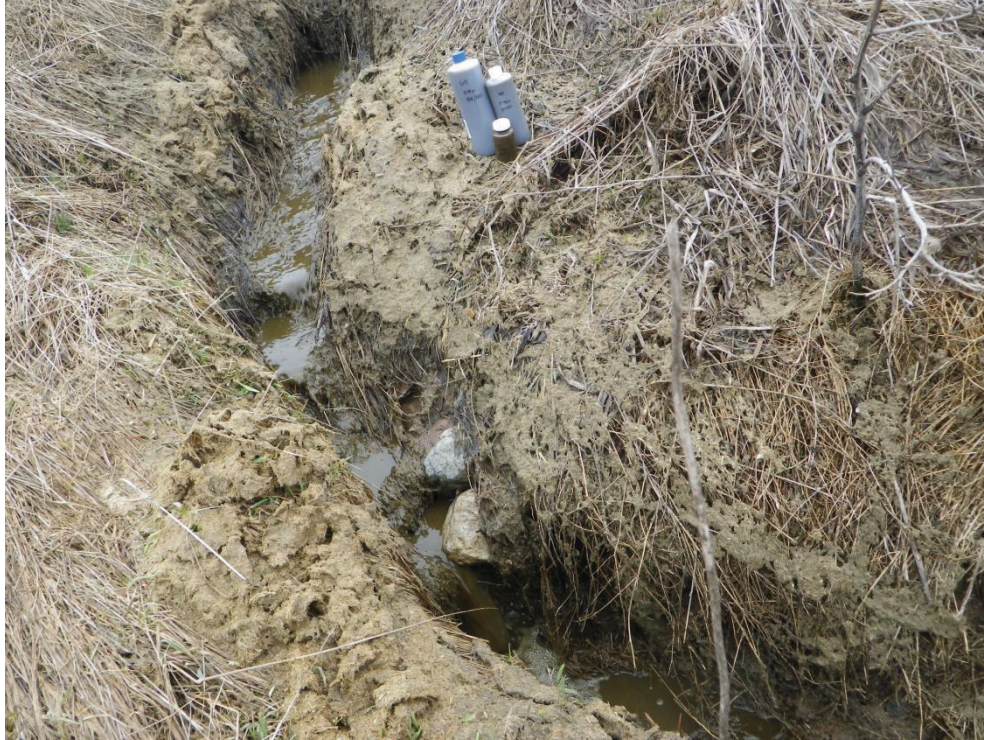
58: IMGP0311.JPG

Description: Sample S04, in east pathway near the elevation change in the field north of the Milk Cow Barn.

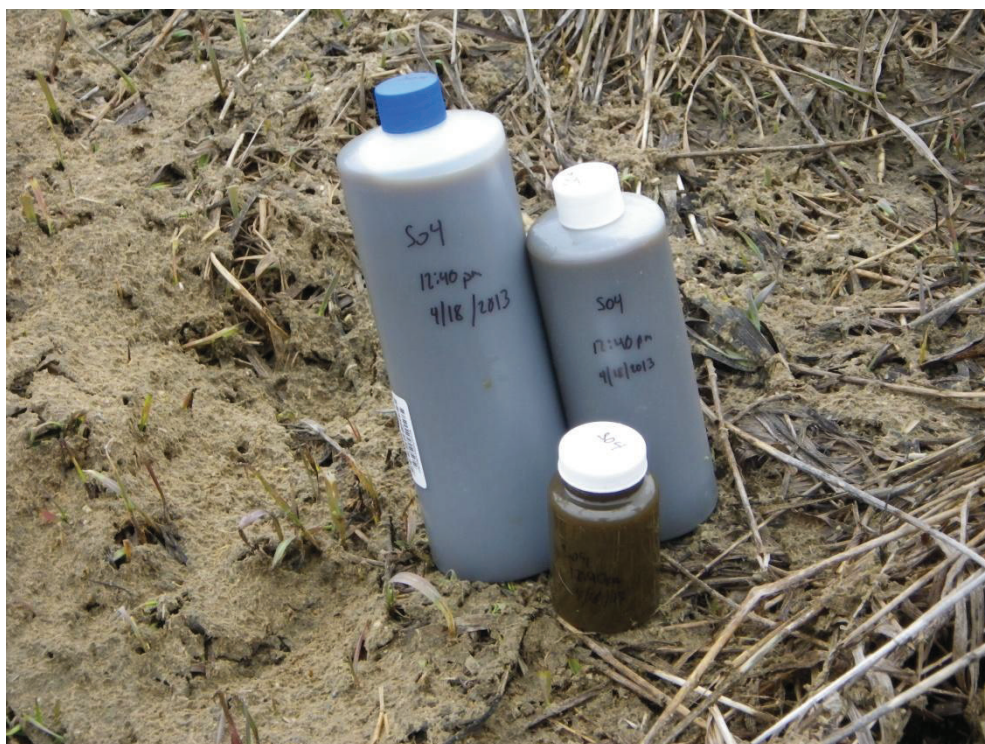
59: IMGP0312.JPG

Description: Sample S04, in east pathway near the elevation change in the field north of the Milk Cow Barn.

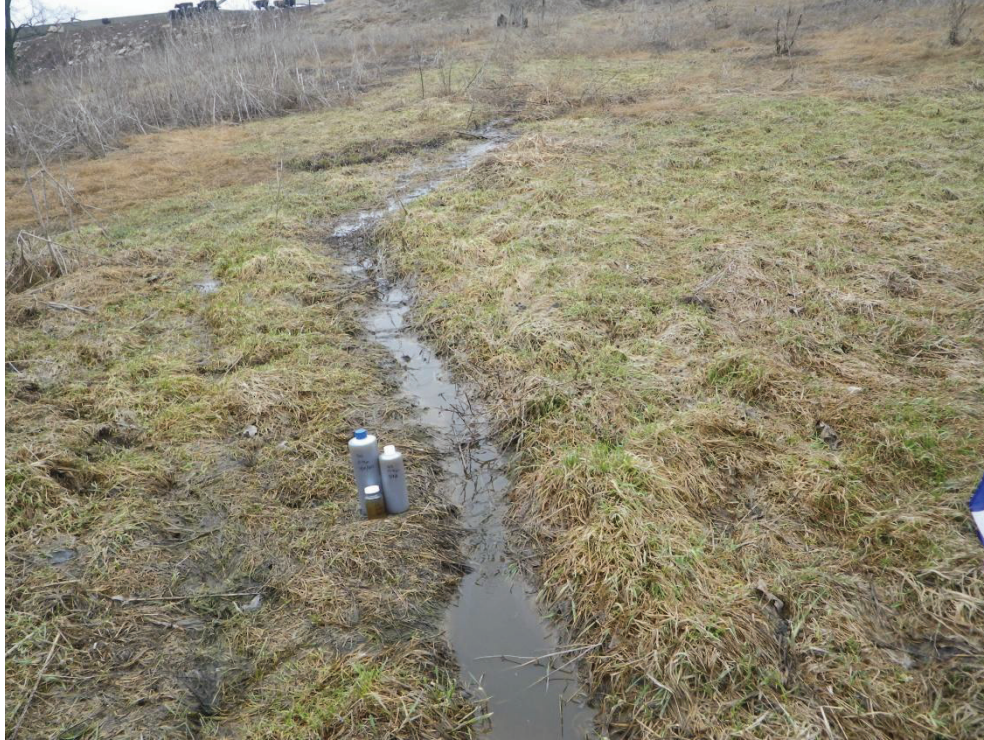
60: IMGP0313.JPG

Description: Sample S05, in flow pathway through field north of the Milk Cow Barn.

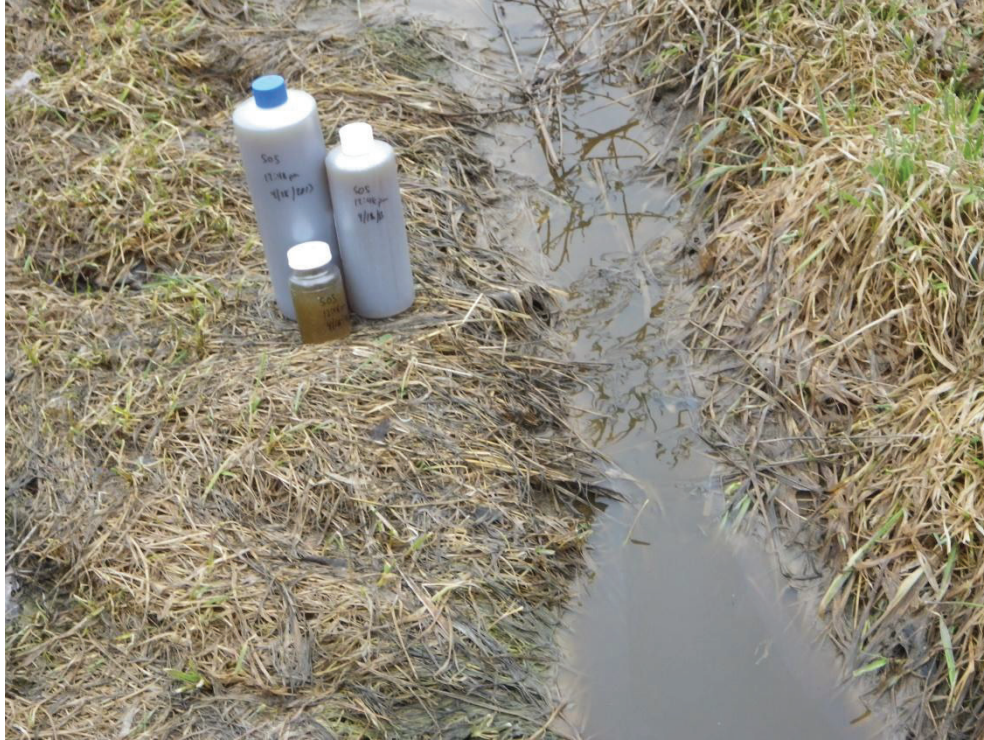
61: IMGP0314.JPG

Description: Sample S05, in flow pathway through field north of the Milk Cow Barn.

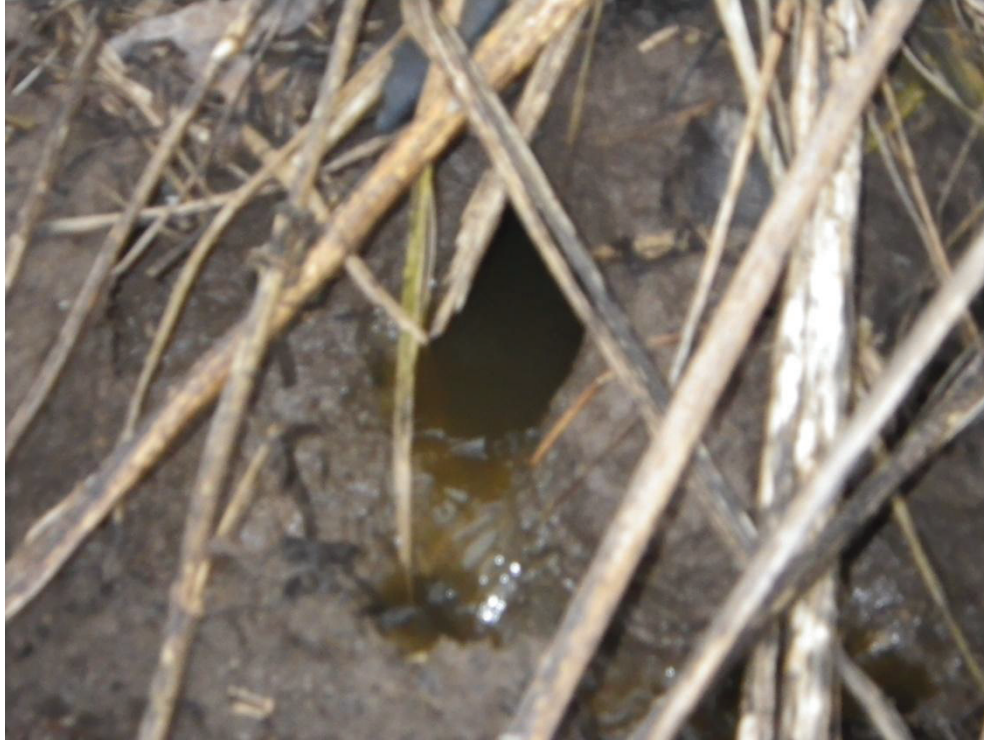
62: IMGP0315.JPG

Description: Portion of pathway on the north end of the field north of the Milk Cow Barn leading to unnamed tributary.
